Flood Proofing Systems & **Techniques**

Examples of flood proofed structures in the United States

US Army Corps of Engineers

December 1984

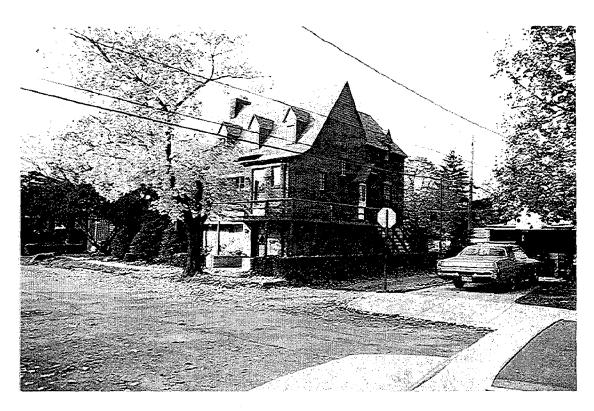
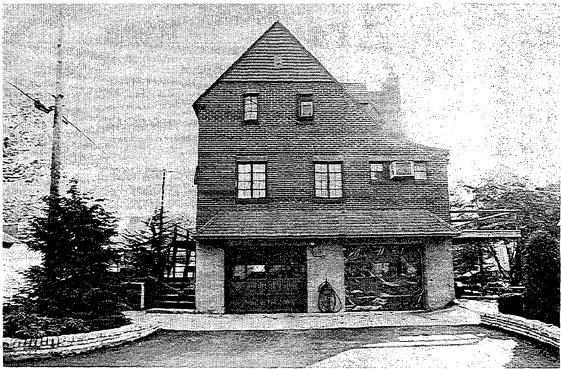
Figure A1. Brick house raised on concrete and concrete block foundation

Two-story, singlefamily, brick bungalow
raised on concrete and
concrete block
foundation, Milton,
Pennsylvania

Flooding from the West Branch of the Susquehanna River put as much as 7 feet of water on the first floor of the house. In 1975, the owner made a decision to raise the entire structure and place it on concrete and concrete block foundation walls. The house was raised using beams and jacks, and then foundation walls were built atop the old walls to a height of 88 inches above ground level (approximately 4 inches above the flood of record for that area, which was Tropical Storm Agnes in 1972). Because of the brick-veneer exterior, jacking procedures had to be precisely controlled to prevent damage.

The heating system and hot-water heater are raised 2 feet to prevent damage from minor flooding. Flood-susceptible mechanical and electrical components of these systems are equipped with quick disconnects to facilitate removal prior to major flooding.

The raising of the house was completed in 1976 at an estimated cost of \$11,300 for foundation work and materials. Much of the actual labor involved was performed by the owner, thus reducing costs below what a contractor would have charged. The ground level was designed for use as a two-car garage and for storage. An elevated wood deck at the new first-floor level surrounds the house on three sides. Two sets of stairs, one interior and one exterior, provide access to the first floor. The structure has not been tested since it was raised; however, excluding a flood greater than the flood of record, the first and second stories would remain dry. The owners are pleased with the outcome of their efforts. Photos of the structure are provided as Figure A1.

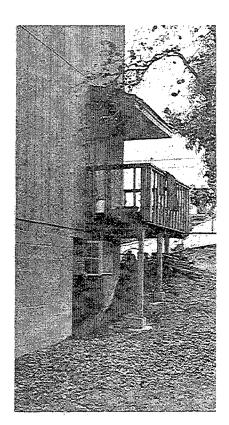
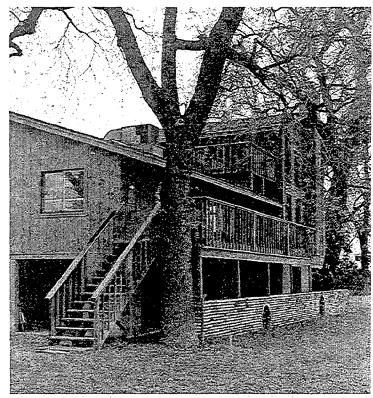
Figure A2. Wood frame house raised on concrete block foundation

Two-story wood frame house raised on concrete block foundation, Sacramento, California This residence was built adjacent to the Sacramento River in an area that is frequently flooded. Depth of flooding may reach 6 to 7 feet. The house is of wood construction and was originally built upon a concrete block wall. The first floor has never flooded. Openings have been left in three of the four basement walls to allow floodwaters to enter the structure in order to equalize hydrostatic pressures. The grade of the lot is such that access to and from the house by way of the front can be accomplished at any time during flooding. Flood duration may be 1 to 2 weeks. Heating and air conditioning units are raised above ground level and are directly beneath the first floor. The brick wall on the river side of the house is also built to allow for the free flow of floodwater (Figure A2). The estimated cost of building the house above flood level is \$15,000. The structure, as designed and constructed, is attractive as well as functional.

Raised air conditioning unit and openings for free flow.

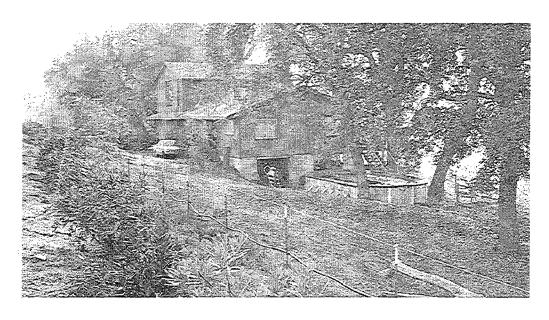
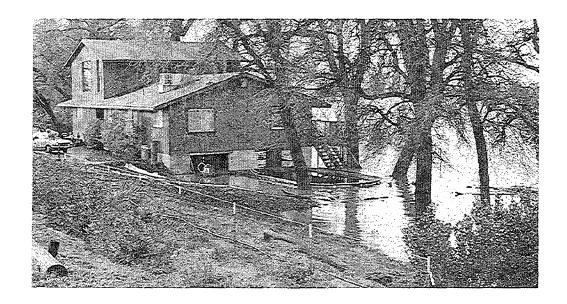
Figure A2.

Without flooding.

With flooding.

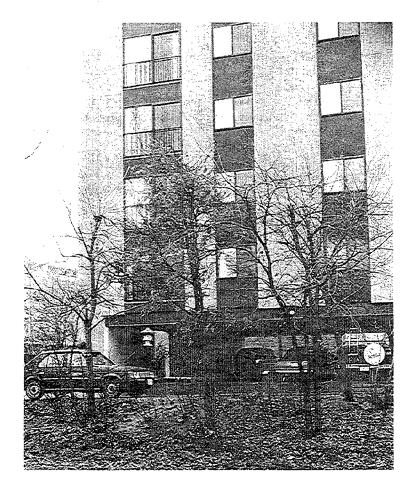
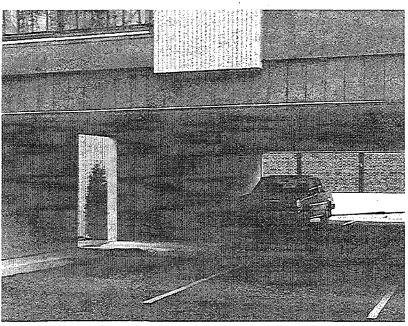
Figure A3. Condominium on concrete wall foundation

Multistory condominium on concrete wall foundation, Rochester, Minnesota This 6-story, 20-unit condominium was constructed in 1978 on the bank of the Zumbro River in Rochester, Minnesota (Figure A3). Flooding from the Zumbro can be of a flash nature and has been known to reach depths of up to 4 feet in the vicinity of the condominium. The structure was designed and built with the structural walls aligned to allow for passage of floodflows. The building is set on concrete walls with concreted spread footings on bedrock. The ground floor, which was designed for parking, is a concrete slab on grade with reinforced concrete support columns. Stair towers and elevator shaft are made of poured concrete. The condominium units are elevated above the regional flood level. The electrical transformer and feed is of waterproof construction. The builder estimates the additional cost of raising the structure was only \$15,000. This demonstrates the modest cost when included in the original design.

First floor parking area, 3-ft depth of flooding in 1978:

Concrete columns aligned in direction of flow.

The Zumbro River last flooded during the summer of 1978. At that time, the building was under construction and some damage occurred because the elevator cage had been inadvertently left at ground level. Damages could easily be avoided should another flood occur.

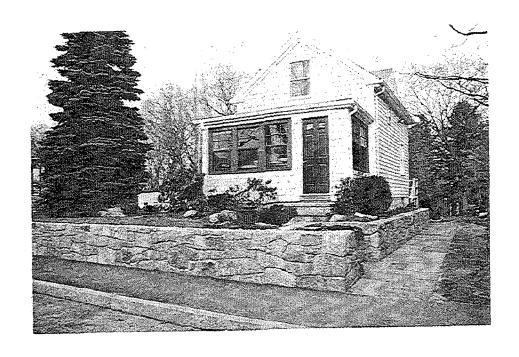
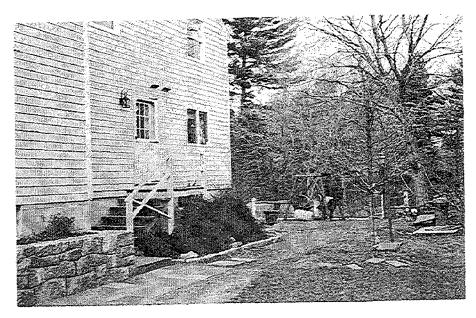
Figure A4. Two-story house raised on fill

Two-story, singlefamily house raised on fill, South Natick, Massachusetts

This house contains 10 rooms on two floors, each floor of which is 2200 square feet. It is located approximately 150 feet from the Charles River, which within the past 40 years has flooded the area three times—March 1968, January 1979, and June 1982. During the floods of 1968 and 1979, floodwaters reached depths of approximately 3 feet in the vicinity of the house. The latest flood, in 1982, caused only minor flooding. Following the March 1968 flood, which caused substantial damage, a decision was made by the owner to flood proof the house. Waterproofing of the basement was too expensive considering there was no guarantee of its effectiveness. It was therefore decided to raise the house 4 feet on a concrete block foundation. This would place the structure above the 1968 flood level. The exterior walls were covered with plastic, and loam was filled in around the extended block foundation. A 3-foot-high stone wall was built around the front portion of the house (Figure A4). All utilities were subsequently moved to the first floor.

During January 1979 flood, neighbors on either side of this structure were forced to evacuate, while the owners of this house remained in their home for the duration of the flood. The only flooding was about 4 inches of water in the basement which was handled by a sump pump.

Although this method has proven to be effective, the house has no auxiliary power source. If the local electric utility were to discontinue service during a flood, the owners would be unable to keep the sump pump active and the water in the basement could rise to a level that would cause damage. Otherwise this flood proofing method appears to be thorough and effective. It should be noted that it is never advisable for occupants to remain in a flood proofed structure when it is surrounded by floodwater since it is always possible that a flood may exceed the design capacity of the flood proofing measure, thus endangering their lives.

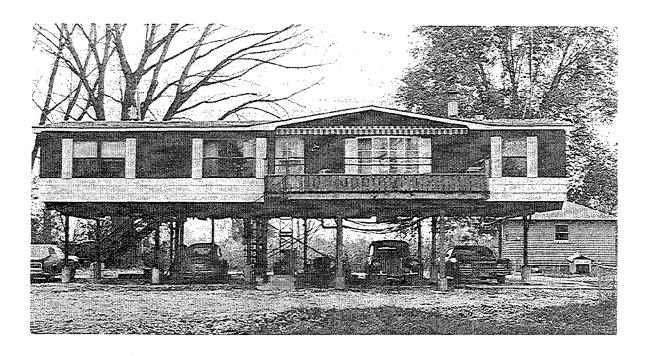
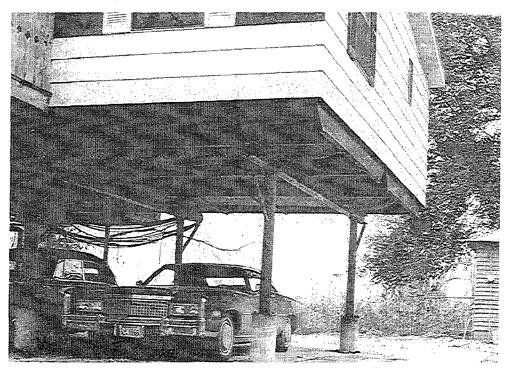
Figure A5. Mobile home raised on steel I-beams

The mobile home is 12 feet wide and 60 feet long. In 1979, it was raised 8 feet above ground level by two cranes and is resting on 12 steel I-beams bolted to the top of concrete cylinders. Three longitudinal beams under the mobile home rest on six transverse beams joining the six pairs of I-beams and concrete cylinders (Figure A5). A deck and stairway were added to the east side of the home after it was raised. The owner has estimated the cost of raising his home at \$1500.

The only structural problems with raising the trailer might result from high winds or ice from the Missouri River striking the I-beams if flooding should occur in winter or early spring. However, the many trees between the river and the mobile home should reduce the likelihood of ice hitting the structure.

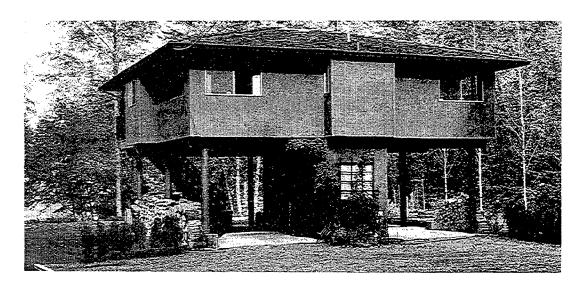
Figure A6. One-story house raised on concrete columns

This residential structure was built in 1971 along the Clackamas River in Oregon. It sits 13 feet above a grade slab on 10-inch-diameter concrete columns (Figure A6). The house rests on timber beams that are secured to the top of the columns by steel straps embedded in and projecting from the columns. An inclosed "core area" at ground level connects with the upper main floor. It contains an access stairway and water and sewer connections. The house itself is of wood frame construction and contains approximately 1300 square feet of space. The owner estimates that the cost of raising the house was \$5000. Under the floodway concept adopted by Clackamas County subsequent to construction of this dwelling, the "core area" would likely not be permitted, particularly since the wider dimension of the core area is oriented perpendicular to flow. Clackamas County also requires a 1-foot freeboard above the 100-year flood; however, this structure has approximately a 3-foot freeboard.

View from street, Clackamas River on other side.

The last significant flood was in January 1972. It peaked at 70,800 cfs and was considered approximately a 20-year flood. The owner states that water was on three sides of the concrete ground slab but did not cover the parking area. The 100-year flood discharge is 110,000 cfs and its duration is about 6 days. Average overbank velocity is about 5 feet per second. The December 1964 flood peak was about 120,000 cfs. Of particular interest is the emergency exit provided by aerial cable tram (basket shown in the third photograph). In the event of major flooding, this provides access from the living level to nearby higher ground at the county road.

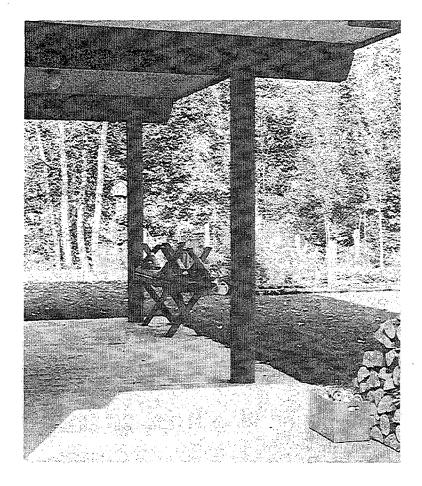
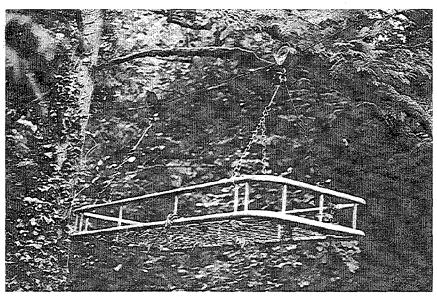
Figure A6.

Closeup of columns and beams.

Aerial cable between structure and high ground.

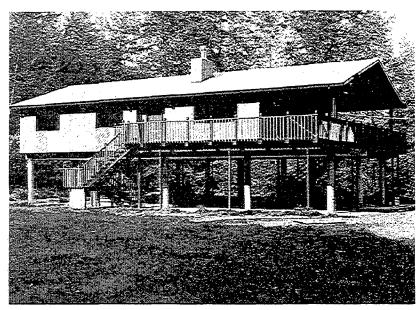
Figure A7. One-story dwelling constructed on columns

Newly constructed onestory dwelling on concrete columns, Oregon City, Oregon This structure (Figure A7) lies adjacent to the dwelling previously described (shown in Figure A6). Flooding conditions are similar. This new construction includes an open stairway, to meet current county flood plain regulations. Such a stairway will permit free passage of floodflows. The dwelling was designed by a consulting engineer firm using design floodflow velocity of 8 feet per second. Reinforced 12-inch-diameter columns on 5-foot-square by 1-foot-deep spread footing support the house. The first-floor elevation is approximately 10 feet above the grade slab. Water and sewer lines are attached to the concrete columns and descend through the grade slab.

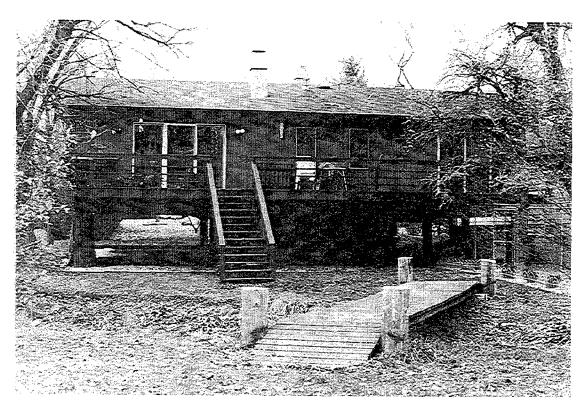
Figure A9. One-story dwelling raised on concrete pillars

This one-story rancher is located 10 feet away from St. Joseph's Creek in Downers Grove, Illinois. The structure was built in 1974 and complies with a village ordinance that existed at the time, requiring houses to be built 3 feet above the 100-year flood level. The house is constructed on an uphill slope which rises away from the creek. It is elevated about 10 feet above ground level on twelve 1-foot-thick poured concrete pillars (Figure A9). Each pillar rests upon a 4- by 4-foot poured concrete slab 2 feet thick. The garage is also raised on six pillars. As constructed, floodwaters are allowed to flow freely. Cost of flood proofing was not disclosed; however, the contractor indicated that it was less expensive to raise the house than it would have been to build a full basement.

One-story dwelling raised on concrete pillars, Downers Grove, Illinois

The area was last flooded in spring 1979. At that time, floodwaters rose to the lowest step of the stairs leading to the raised deck. This was estimated to be a 10-year flood event.

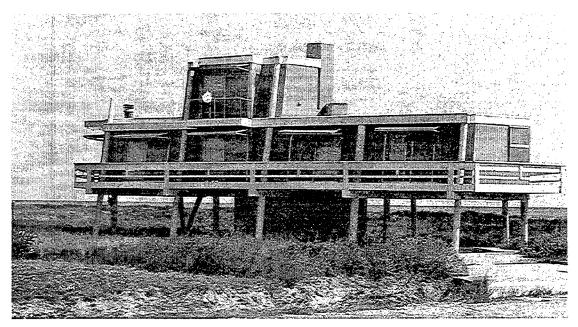
Figure A8. Resort home on timber piling

Resort home on timber piles, Galveston Island, Texas

The house is of wood frame construction and is built within, and connected to, extended wood piles. These batter piles are not only aesthetically pleasing, but also provide greater resistance to the overturning forces of possible wind-driven waves. Window awnings are metal, and designed to fold down, thus serving as storm shutters. The first floor is elevated 8 feet above the ground level.

Front view.

No severe flooding has been experienced by this structure. The only hurricane to strike after its construction was Alicia in August 1983. During that storm, winds were recorded at 130 m.p.h., and the still water surge elevation was 9.5 to 10 feet. It is not believed that wave action was significant at this site, and there was no apparent wind damage.

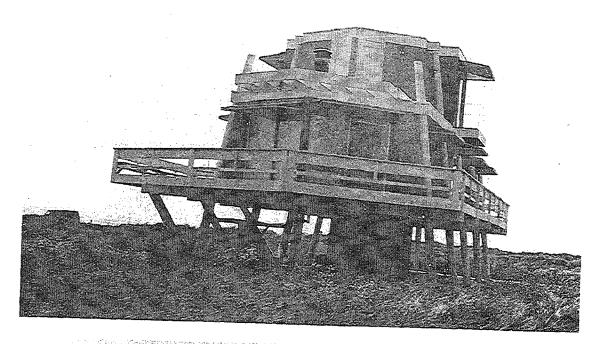
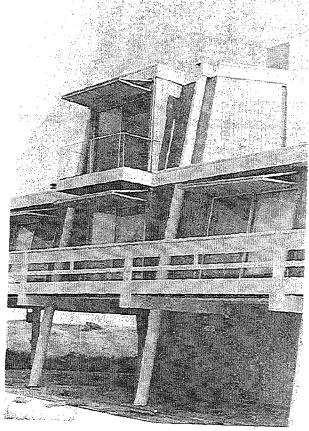
Figure A8.

ABOVE: Side view.

LEFT: Double 2×12 in. stringers throughbolted to timber piles. Piles protected by concrete slab. Note fold up storm shutters.

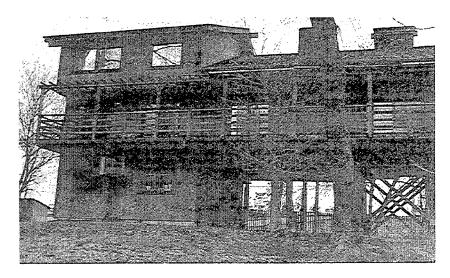
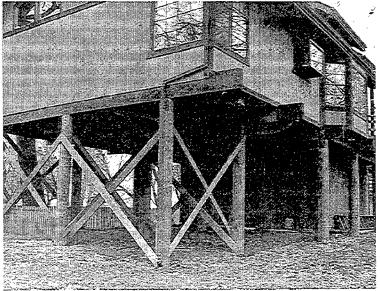
Figure A10. Wood frame structure on wooden posts

Residential two-story wood frame structure on wooden posts, Sacramento, California This house, shown in Figure A10, is elevated 11 feet above ground. It was built on nine wooden posts with 13.5-inch-diameter wooden piers set at 10-foot centers. The piers are set in concrete and bolted to the floor joists with steel plates. It is located about 40 to 50 feet away from the Sacramento River, which floods frequently. Depths of flooding may reach 6 to 7 feet in the vicinity of this house. In addition to the main house being raised, the air conditioning unit, shown in the first photograph, is also raised well above the flood plain. Cost of flood proofing the structure is estimated to be \$8000.

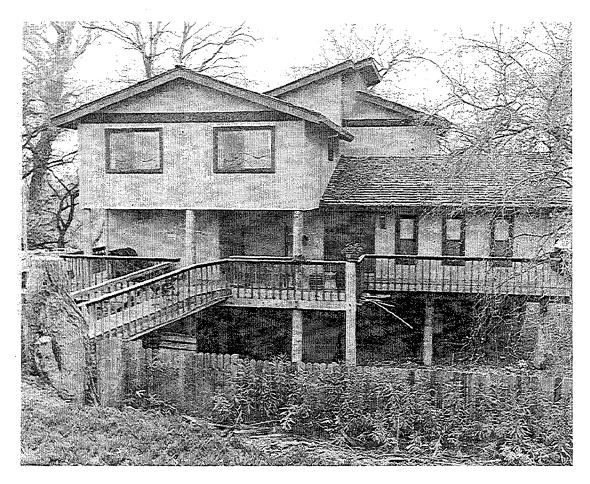
Figure A11. Wood frame structure on wooden posts, with bridge

This structure is built in similar fashion to the one described previously. Located on the Sacramento River, this structure has nearly identical flooding characteristics also. A bridge leads to the first floor from the road (Figure A11). The wooden posts upon which the house rests are actually built into the house itself.

Residential two-story wood frame structure on wooden posts, Sacramento, California

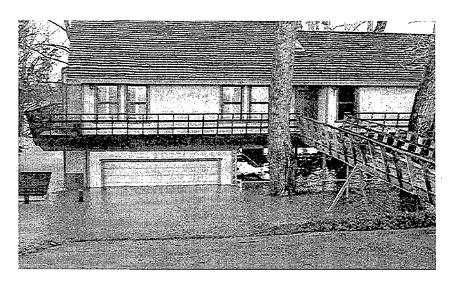
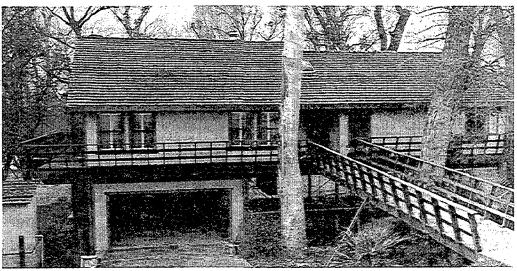
Figure A12. Two-story dwelling on steel posts

Two-story dwelling on steel posts, Sacramento, California Located along the Sacramento River, this wooden frame house is raised 9.5 feet. Steel I-beams run the length of the house and are attached to 12 steel posts which are 6 inches in diameter. The posts are attached to the I-beams with bolts and are set in concrete. The wooden floor joists rest upon the I-beams (Figure A12).

Electrical circuit boxes and the heating/air conditioning unit are raised about 5 to 6 feet above the flood plain. The two-car garage is located beneath the first-floor ground level. A wooden bridge runs from the first floor to the road. Cost to flood proof the house is estimated at \$5000.

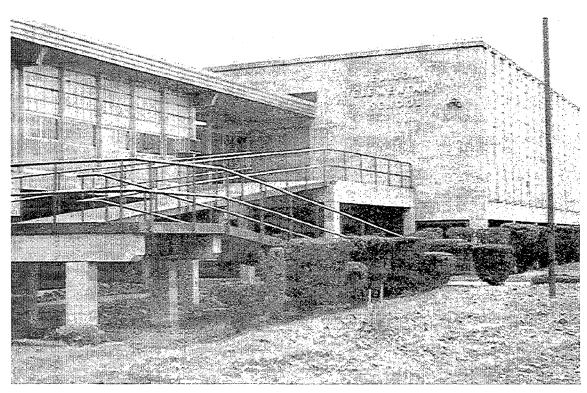
Figure A14. School building elevated on concrete structural beams and columns

Edison Elementary School elevated on concrete structural beams and columns, Jefferson County, Ohio Edison Elementary School was constructed in 1961 on reinforced concrete piles, with the finished floor approximately 12 feet above ground level (Figure A14). The piles rest on concrete footings approximately 4 feet below ground level. The floor is constructed of prestressed concrete slabs.

Ramp leading to entrance.

This area of Jefferson County is susceptible to backwater flooding from the Ohio River. The building's first floor is at the 500-year flood level, which approximates the March 1936 flood. The entire structure is raised, with the exception of a storage shed located below the finished floor. This shed is used to store maintenance equipment, such as lawn mowers, which could easily be removed prior to flooding. The school's heating and cooling are supplied by individual electric room units, all above the finished floor. A ramp leads from the ground level to the first floor. Outside stairways also permit access to and from the building. It is estimated that the school cost \$500,000 to build, of which \$75,000 was for design and construction in an elevated position. While the school property has flooded on several occasions, the school itself has remained dry and unthreatened.

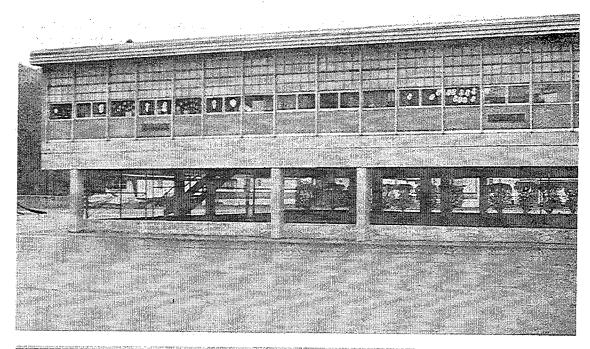
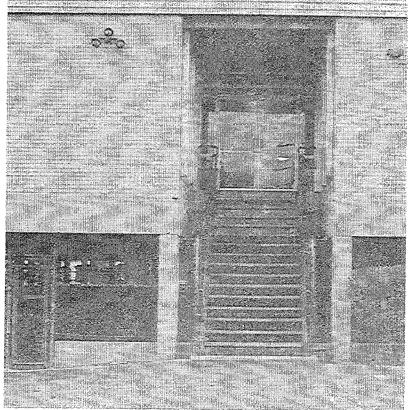
Figure A14.

ABOVE: Flow-through area. LEFT: Entrance and storage space.

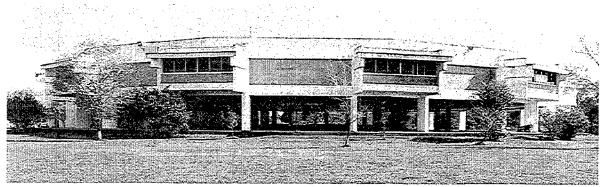
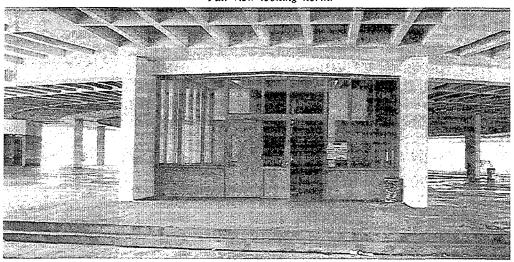
Figure A15. School building raised on concrete columns.

Sebastian Roy Elementary School raised on concrete columns, Verret, Louisiana The Sebastien Roy Elementary School in Verret, Louisiana, is subject to hurricane surges from both Lake Borgne and Breton Sound. Flooding has been known to reach depths of 7 feet (Hurricane Betsey, 1965) in the immediate area. The school is elevated approximately 10 feet above ground level by reinforced concrete columns. These columns rest on a reinforced concrete slab (Figure A15). The foundation characteristics are such that creosoted pilings were necessary to support the slab. Walls of the school itself are brick and concrete with metal panels for inside walls. The floor is also reinforced concrete.

run view looking north.

main entrance to schoot.

The school has an area of 59,760 square feet and was completed in 1968 at a cost of approximately \$1.25 million. Heating and air conditioning units are located on the roof. The electric transformers are raised about 5 feet above ground on a concrete platform.

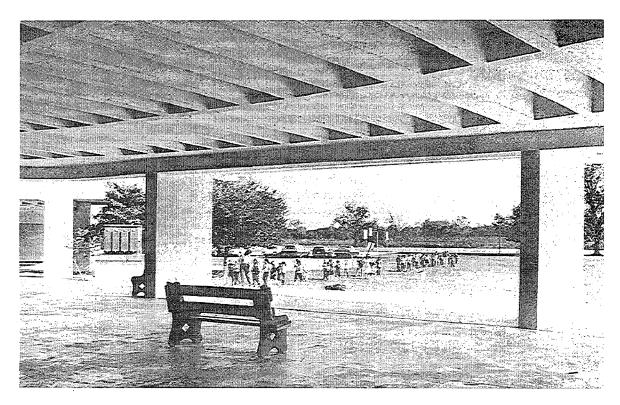
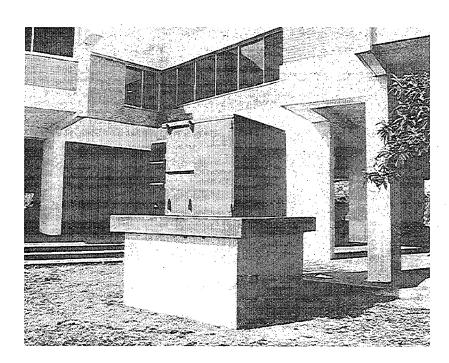
Figure A15.

Subfloor structure at school.

Elevated electrical main.

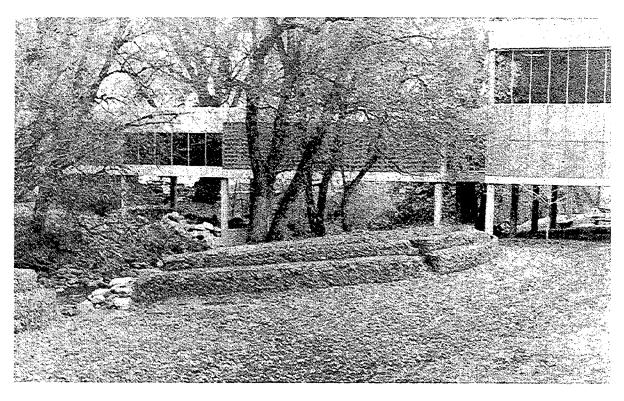
Figure A16. Two-building library raised on reinforced concrete piers

City of Boulder library, raised on reinforced concrete piers, Boulder, Colorado In 1974, the City of Boulder constructed a public library consisting of two buildings on opposite sides of Boulder Creek. The buildings are connected by a covered walkway (Figure A16). The terrain is such that the walkway and portions of the two buildings are raised 8 feet above the overbank on reinforced concrete piers. Photos of the structure indicate that the floor is made of reinforced concrete and the walls are precast.

Good landscaping shows harmony with the building.

The structure is both aesthetically pleasing and environmentally sound. The obstruction of the floodway is minimal. Flooding of Boulder Creek is of a flash nature, and very little can be done to prepare for a flood event. The design of the building requires literally no advance preparation. One possible problem with the location of the library is that column footings may be subject to erosion during severe floods due to the high velocities that are possible.

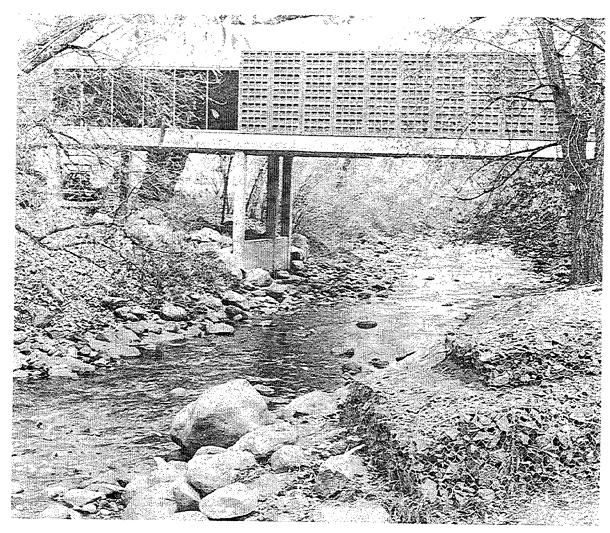
Boulder Creek flows under the building. Figure A16.

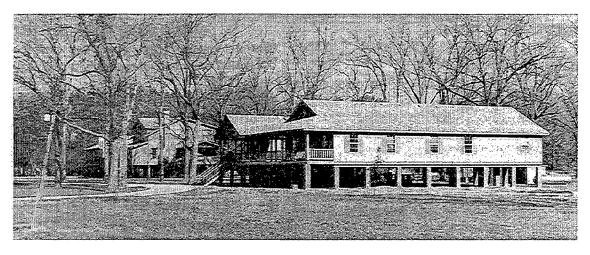
Figure A17. Hunting lodge raised on piers of concrete blocks

Hager Hinge Company Hunting Lodge, raised on piers of concrete blocks, St. Charles County, Missouri The Hager Hinge Company raised an existing hunting lodge in St. Charles County, Missouri, 8 feet above ground level following a Mississippi River flood in 1973. This represented an elevation higher than the 1973 flood. Since that time, the river, located about 1 mile from the lodge, has again flooded, putting as much as 2 feet of water on the property. While the building is elevated well above record flood heights, it is still 3 feet below the 100-year flood elevation. Duration of flooding for the area can be as long as a month or more.

The lodge itself is of wood frame construction. It was placed on a series of piers made of 16-inch-square by 8-inch-high concrete blocks; the piers rest on concrete footings (Figure A17). Cost to raise the structure (excluding cost of materials and labor to build the footings and piers) is estimated at \$3000 to \$4000.

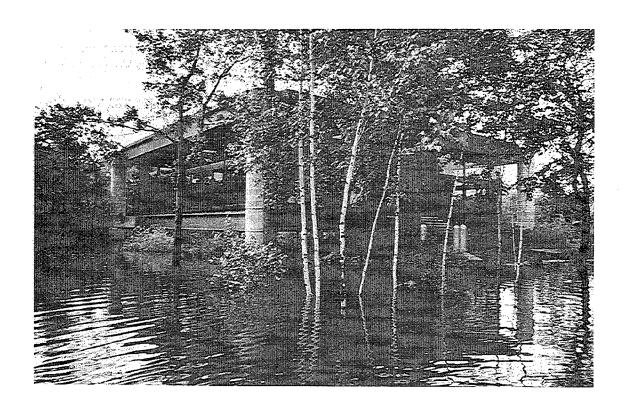
The Hillier Group office building raised on concrete corner columns, Princeton, New Jersey

This commercial office building, completed in 1973, has a first-floor elevation of 63 feet, National Geodetic Vertical Datum (NGVD). It has a steel frame that is hung on four concrete columns. Exterior glass walls enclose the building, and a parking area exists beneath the raised building (Figure A18). Cost of construction was \$274,000.

The 100-year flood elevation at this site is estimated to be 62 feet, NGVD. Since the building was completed, two 100-year floods on Little Bear Brook occurred, both in 1975 within 2 weeks of each other. The only damage sustained during the floods was an accumulation of mud on the parking lot. The owner indicated that, during the floods, floodwaters flowed freely beneath the building and no debris collected.

Figure A18. Office building raised on concrete corner columns

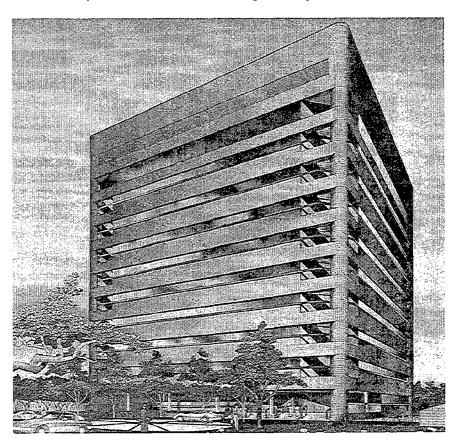
J. M. Huber Corporate Headquarters, raised on steel piles, Edison, New Jersey This 11-story office building, shown under construction in 1983 (Figure A19), contains 200,000 square feet of space. Estimated cost of construction is \$20 million. The structure has a steel frame with composite metal deck and is built directly over the South Branch Rahway River. Due to the poor bearing capacity of the soil and the location over the stream, the building's foundation is on steel piles that go down to bedrock. The first floor is supported 15 feet above the stream on steel columns encased between ground level and the first floor with concrete. Exterior walls are prefabricated tile panels with two-sided structural glazed windows.

Figure A19. Artist's conception of office building raised on street piles.

The building's main entrance is on the north facade where a retaining wall was built. The retaining wall runs parallel and is on the stream encroachment line, with the rest of the facility supported on structural stilts over the floodway.

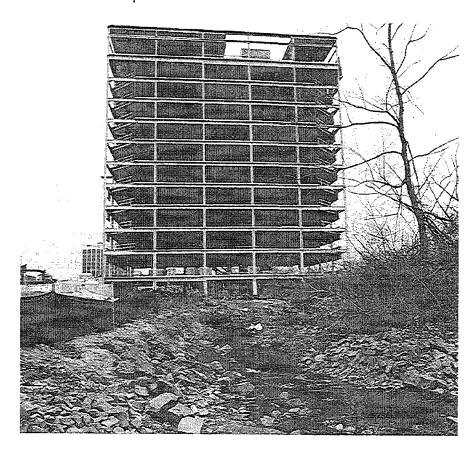
Figure A19.

Building under construction.

During construction the site was flooded several times south of the new stream encroachment line, but construction has not been hindered.

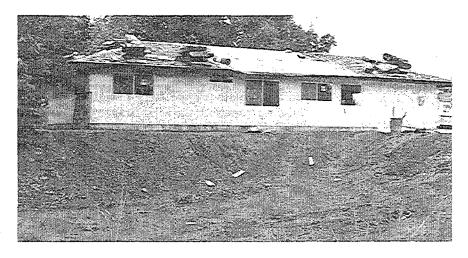
Figure A20. One-story dwelling raised on fill

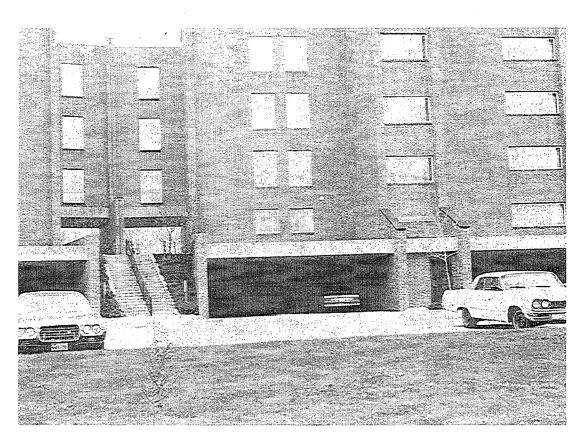
The ground level below each structure is used for open-ended parking stalls (Figure A21). Apartment units are 10 feet above ground, thus providing flood protection greater than the 500-year level. A small lobby is located on the ground level of each unit. On the opposite side of the buildings from Big Papillion Creek is an artificial lake. The ground floor on that side is below an embankment. Thus, the parking stalls extend only partway beneath the buildings.

Figure A21. Multistory apartment buildings on fill with ground-level parking

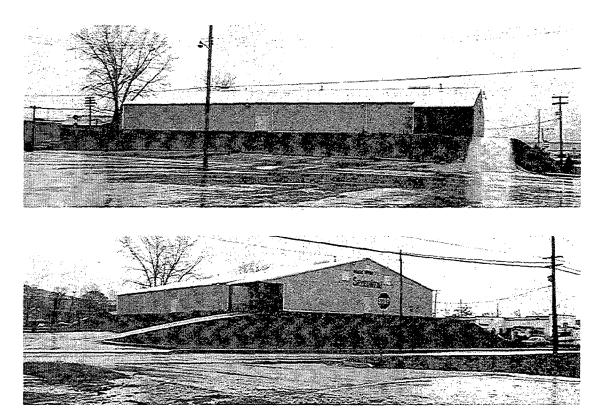
Roller-skating rink raised on fill, Lock Haven, Pennsylvania Built in 1978, this one-story roller-skating rink was constructed on compacted fill in order to raise it above the 100-year flood plain (Figure A22). Lock Haven is subject to periodic flooding from both the West Branch of the Susquehanna River and Bald Eagle Creek, a tributary to the West Branch. Earthfill was placed at the site in 8-inch lifts and compacted to 90 percent. Fill was placed to a maximum height of 10 feet above grade.

The foundation of the skating rink is a continuous concrete footer, 24 inches wide and 12 inches deep, enlarged to 5-foot by 5-inch pads under structural steel columns. Footers bear on the compacted earthfill. Foundation walls are 12-inch concrete block. The floor is a reinforced concrete slab on grade tied to the foundation walls by steel reinforcing bars. First-floor walls are sheet metal over a structural steel frame. Access to the structure is by way of a ramp. The cost to flood proof the structure is estimated to be \$30,000, including the cost of the compacted fill and enlarged column pads.

Figure A22. Roller-skating rink raised on fill

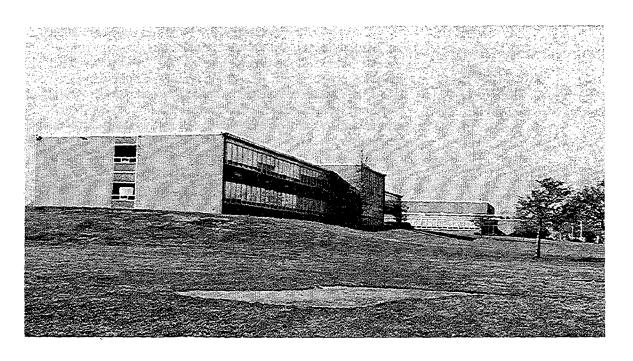
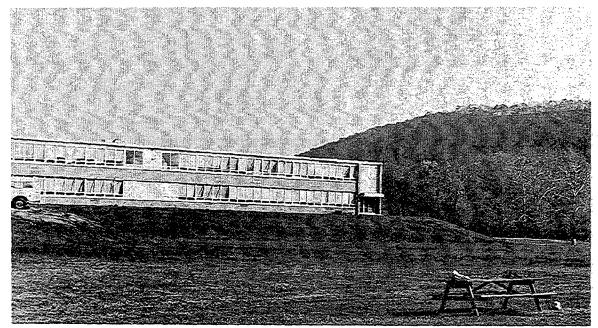
The first-floor design elevation was based on the 1936 flood, which was the flood of record at the time of construction. Since 1961, two major floods have occurred—in June 1972 and September 1975. Neither flood reached the level of the first floor; however, the 1972 flood (Tropical Storm Agnes) came within 4 feet of the first floor. During that flood, hydrostatic pressure from saturation of the earthfill caused a wall to collapse, inundating the gymnasium. Future floods may continue to present a problem to the structure by saturating the apparently pervious earthfill. Thus, the auditorium may continue to be susceptible to inundation from seepage.

Figure A24. School building elevated on columns and fill

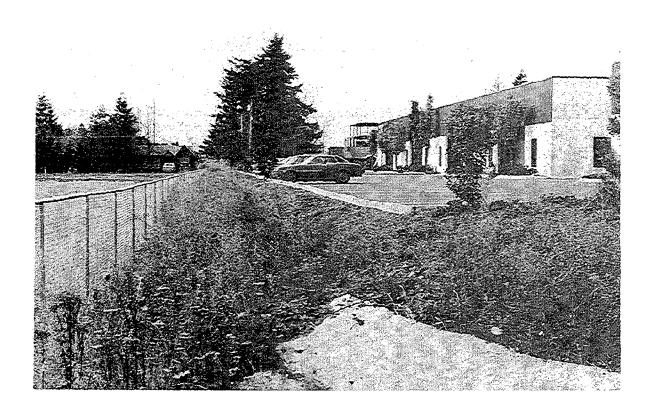
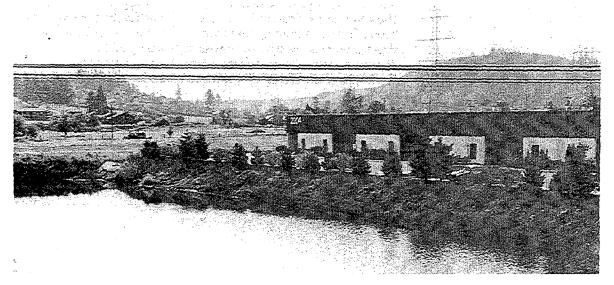
Commercial offices elevated on earthfill, Gresham, Oregon Two one-story commercial office buildings were constructed on fill material to elevate them from flooding from Fairview Creek (Figure A25). Approximately 36,000 cubic yards of fill material, primarily gravel, was excavated from the adjacent flood plain and compacted to a depth of 3 to 4 feet. As a result, a pond was created between the creek and the buildings. Total area raised is approximately 4 acres, including the structures and parking areas. Access to the facility is from the main road, which remains flood free during flood events on Fairview Creek. Cost of raising the structure on fill is estimated to be \$36,000.

The office buildings were completed about October 1979. The highest flood level since then occurred in January 1980, at which time water crested about 8 inches below the top of the fill and receded in a matter of hours. This flood represented about a 10-year event.

Figure A25. Commercial building elevated on earthfill

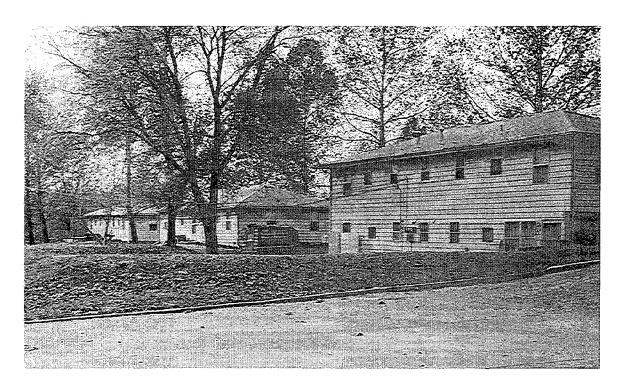
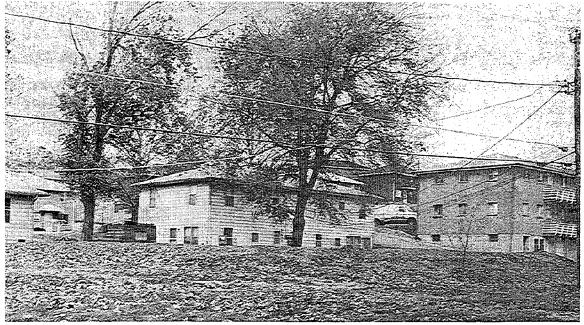
This building, which was originally a single-family house but later converted to a multiunit apartment house, was built adjacent to similar structures along Line Creek, a small stream in Kansas City which floods frequently. The foundation of the structure is poured concrete, and the walls and floors are of wood-frame construction. The basement of the building serves as an apartment unit. When constructed during the 1970s, the building was unprotected from flooding. Later, an earthen levee was built on the streamside of the apartment house and tied into high ground near the front of the structure. The photographs shown in Figure A26 provide an idea of the height and slope of the levee. Height varies from 2 to 4 feet above the existing ground level. The levee is covered with grass to prevent erosion. A 6-inch pipe with a flap gate on the streamside serves as a gravity drain for interior ponded runoff. Flooding experience has shown this interior drainage system to work well.

Figure A26. Apartment building with ring levee

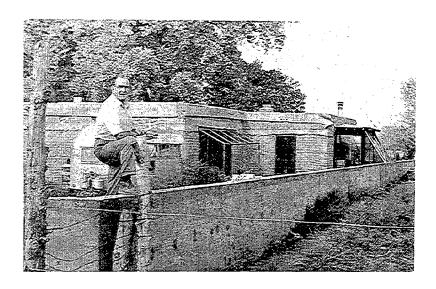
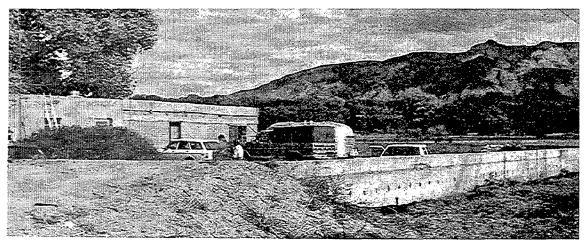
Single-family house with concrete levee retaining wall, Corrales, New Mexico The owners of this house had a reinforced concrete levee retaining wall (Figure A27) built around their house in 1978 to protect the structure from flooding from both the Rio Grande and Arroyo de las Montoyas. Cost of construction is estimated to be \$11,000. The wall is rectangular in shape, approximately 120 feet wide and 200 feet long. Height varies from 1.5 feet to 3.5 feet, depending on ground elevation. Access to the house is by means of both an earthen ramp built over the wall for vehicles and by wooden steps. There are no provisions for handling interior drainage, although a gasoline-driven pump has been recommended by the Corps of Engineers.

Figure A27. Single-family dwelling with concrete levee retaining wall

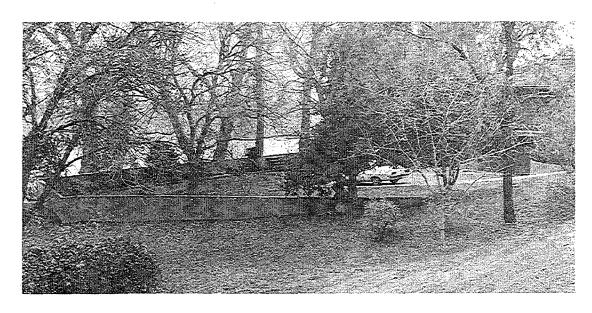
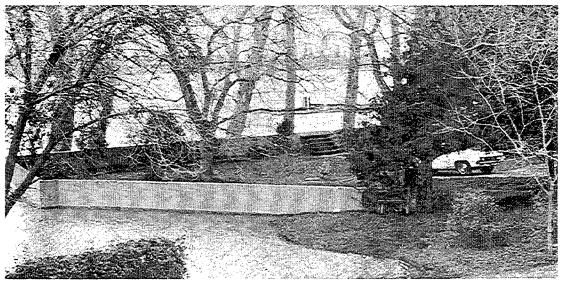
Residential two-story structure with concrete and concrete block retaining wall, Sacramento, California

A concrete retaining wall encloses this house and yard on three sides to protect it from flooding from the Sacramento River. The wall is 5 feet high and 6 inches thick and approximately 300 feet long. The property is accessible from the levee road which is above flood level. The first floor of the house is approximately at the same level as the road. Cost of construction of the flood wall is estimated to be \$10,000. The photographs presented in Figure A28 show the structure before and during flooding.

Figure A28 Two-story residence with concrete and concrete block retaining wall

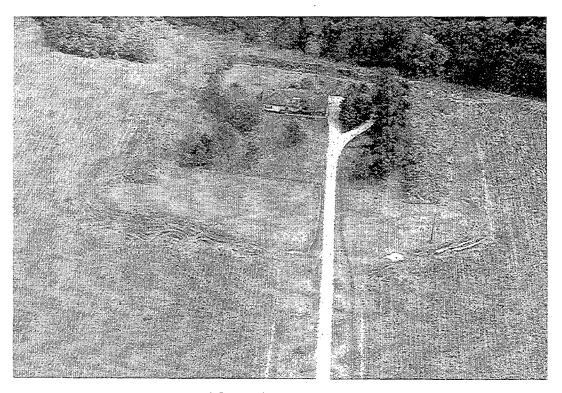
In 1973 the owner of the house and surrounding property built the first levee, which failed during the 1973 flood due to inadequate height. In 1974, a second, higher levee was constructed at an estimated cost of \$6000. This levee surrounds the house on all sides, is 36 feet wide at the base, and 12 feet wide at the crown. The front levee is graded down to a height of about 4 feet during flood-free periods to allow access to the property. During flood periods, this front levee would require about 12 hours' construction time to rebuild.

The present levee was effective during both the 1974 and 1975 floods. Two gasoline-operated sump pumps handle interior drainage. An aerial photo of the house and surrounding levee is shown in Figure A29.

Figure A29. Residential structure with earthen levee

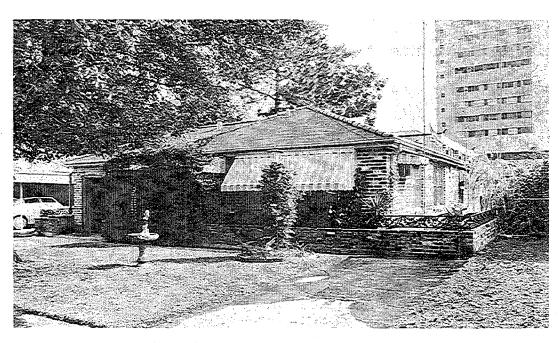
One story, single-family residence with reinforced concrete floodwall, Jefferson Parish, Louisiana

BELOW: Front of house and floodwall. Notice brick veneer on front of concrete floodwall. Side bricks are painted. Front bricks are real.

Figure A30. Residence with reinforced concrete floodwall

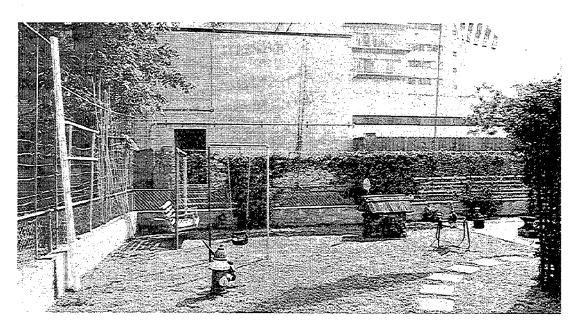
Owner inserting suction line and filter for gasoline driven pump. This is a standby pump in case of electrical outages.

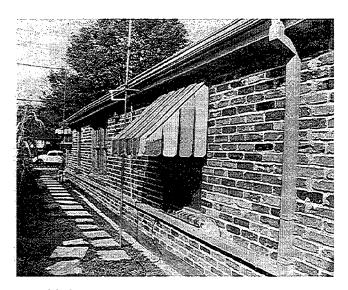
Figure A30.

Modified gutter on south side of house. Discharge goes to front of house.

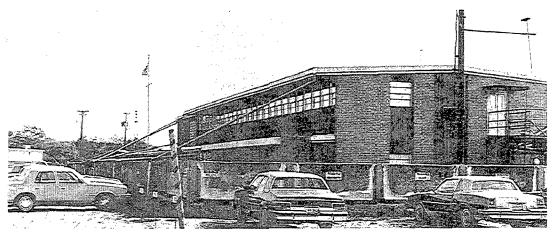
This industry is located on Berwick Bay near the confluence of Bayou Boeuf and the Atchafalaya River. Numerous tugs and offshore supply and service boats are operated out of its extensive docking and servicing facilities; thus, its operation requires a location in the flood plain. Because of its potential flooding from the Atchafalaya River, the company has constructed a concrete floodwall around its 15,000-square-foot building that consists of a metal frame warehouse and a twostory office building, both on a concrete slab. The floodwall is constructed to an elevation approximately 5 feet above ground level and is 8 inches thick (Figure A31). It is braced with 6-inch 1-beams. The base of the wall extends 3 feet below ground and rests on a concrete foundation. The wall has gates that are removed during flood-free periods to allow ingress or egress. It is estimated that the flood proofing system cost \$500,000. The wall was constructed in 1974, following a disastrous flood the year before which put about 3 feet of water on the first floor of the main building.

Marine building and floodwall looking southeast.

Figure A31. Warehouse and office building with concrete floodwall

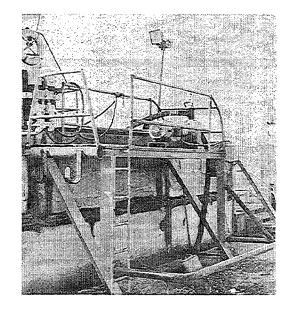
Sump pump system along south floodwall.

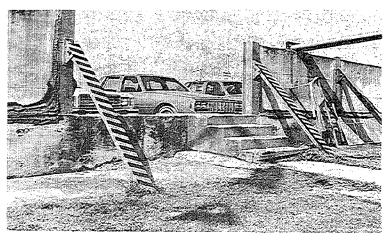
Figure A31.

Personnel entrance in west floodwall.

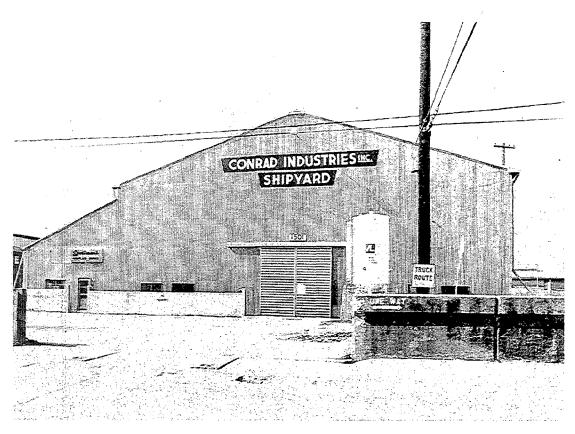
Barge construction and boat repair company with a concrete floodwall, Morgan City, Louisiana Located in the vicinity of the industry previously discussed, this barge construction and boat repair operation likewise requires siting in the flood plain adjacent to Berwick Bay. The main structure is a two-story 16,000-square-foot metal building protected by a large concrete floodwall (Figure A32). Built in 1975 following major flooding in 1973, the 8-inch-thick wall was constructed to an elevation of 5.5 feet above ground level and rests on a concrete foundation several feet below the surface. The floodwall is reinforced with steel rebars and is braced by steel tie-bars. Ingress and egress are allowed through steel gates that are welded shut during floods. Rough estimates of the cost of the floodwall run over \$100,000.

Front of building. Note Morgan City floodwall in foreground.

Figure A32. Industrial building with a concrete floodwall

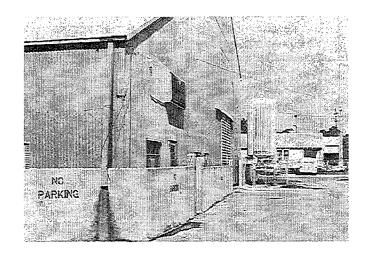
Front of floodwall looking northwest.

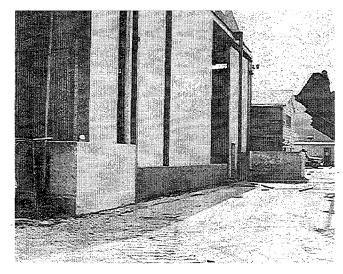
Figure A32.

West floodwall (this floodwall fronts on the Atchafalaya River.

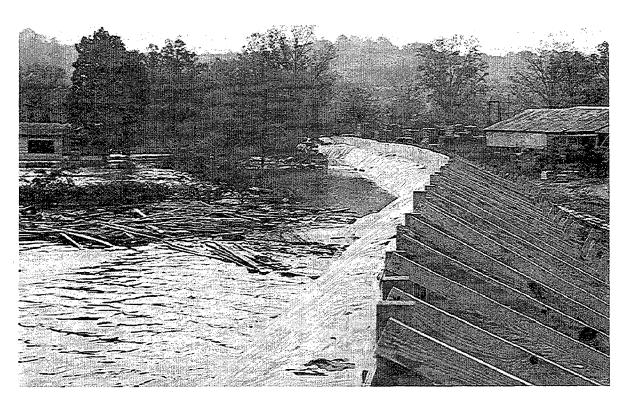
Figure A33. Sawmill with earthen levee

This 20 acre site contains a sawmill, finishing plant, and storage facilities for both raw materials and finished products. The buildings, equipment, raw materials, and finished products have an estimated market value of about \$12 million. Floods can thus be very damaging to the operation, particularly since flooding from the Mississippi River can last up to 90 days or more with depths of up to 10 feet. Construction of an earthen levee (Figure A33) around the entire sawmill complex was begun in 1970, with continuous upgrading and repair of the system since then. The levee has a top elevation of approximately 102 feet, National Geodetic Vertical Datum (NGVD). This compares to the 100-year flood elevation for the area of 104 feet, NGVD. Four 30-inch steel culverts with flap gates provide interior drainage during flood-free periods, while portable pumps are moved in temporarily during high water to handle interior drainage. Temporary wavewash protection is applied prior to a flood emergency. Cost of construction of the levee system over the last 10 years is estimated at \$1 million.

Flooding experience at the sawmill since construction of the levee has been mixed. The 1973 flood overtopped the existing structure with no estimate as to the total damage caused. That flood was approximately a 45-year event. The levee was repaired and upgraded following that flood. It subsequently withstood the floods of 1974, 1975, and 1979. The present level of flood protection is about as great as can be economically undertaken. The current height of the levee should keep the compound dry during a repeat of the 1973 flood. A major limitation now is the additional space required for further raising of the structure.

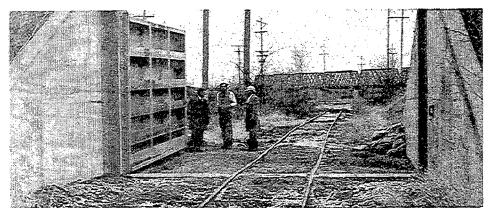
Figure A34. Manufacturing plant with ring levee and flood gate system

This large industrial complex contains several scattered buildings, all of which are subject to flooding from the Illinois River to the southeast and Kickapoo Creek to the north. The complex is protected by an extensive levee and floodgate system that was built in stages and is currently 21,000 feet in length with an average height of 12 to 15 feet. On the southern face of the levee is an unprotected opening that allows industrial traffic to pass. During flood emergencies, this opening is closed by means of sandbags and fill.

Following a flash flood from Kickapoo Creek in 1974, the company made some additions to the levee system. A new section was constructed along the western portion of the property which included two openings fitted with floodgates approximately 10 feet high and 16 feet wide (Figure A34). These openings are to allow railroad access into the complex. A third floodgate was built at a viaduct which connects the east and west portions of the complex. This viaduct cuts through a bank supporting a railroad line elevated 12 feet above ground level. With the floodgate closed, the bank serves as a secondary levee to protect one end of the complex should flooding occur at the other end. These three floodgates are built to lock into a

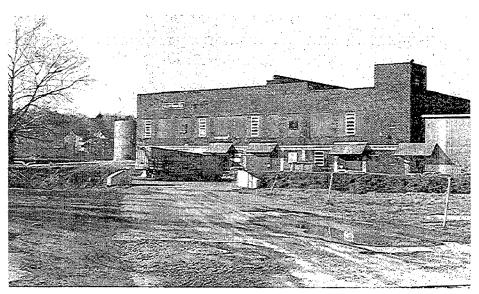
Front view of plant and gate.

Figure A35. Manufacturing plant with ring levee

This paper manufacturing plant is located partially within the 100- and 500-year flood plain of the West Branch of Brandywine Creek. Flooding occurs on the average of twice a year with overbank depths reaching 3 to 4 feet and lasting for several hours. The original plant was constructed over 200 years ago, with an addition added around 1920. The structure has a concrete superstructure with a brick-veneer exterior, and a mat foundation with a basement under part of the building. The building is two stories high with over 60,000 square feet of working area. Due to the age of the structure, management made a decision to build a ring levee around the entire plant (Figure 35) rather than use another flood proofing method. The levee has a top width of 9 feet and a bottom width of 15 feet and is 3 feet high. A 24-foot opening in the levee provides access to the building. Three 1.25-inch plywood panels are to be used to close the opening during flooding. The panels slide into metal channels, but no gaskets or seals are used to eliminate seepage. At other times the panels are stored in an accessible location. Cost of constructing the levee is estimated to be \$10,000.

The plant operates 24 hours a day, seven days a week. Since its construction, the levee has allowed the plant to stay open during two floods. Both times, high water did not reach the level of the access opening; therefore, the flood shield (plywood panels) was not needed. The general manager estimates that the levee has paid for itself during the two flood events by eliminating damages and allowing the plant to remain in operation.

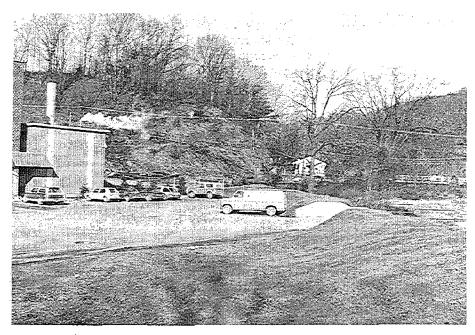
Inside view of plant and gate.

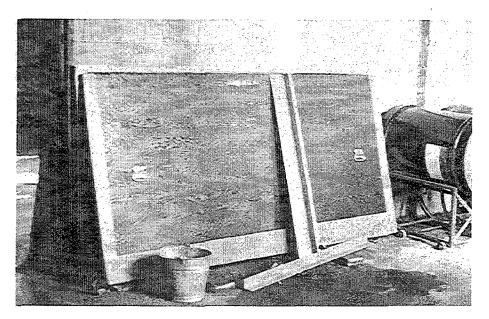
Figure A35.

Stored plywood panels.
